Manhole Inspection Summary

Manhole # S11C1_006MH

Insp Date: **4/14/08 9:59 AM**

Location Address: **1401 S. Wedgewood**

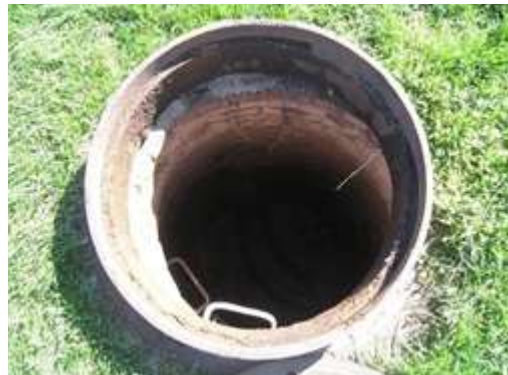
Defect 2

Condition: ☐ Sound ☐ Cracked ☒ Root Intrusion ☒ Loose Brick ☐ Deteriorated

Infiltration: ☐ None ☐ Joint ☐ Cracks ☐ Mortar ☒ Roots ☐ Wall

chimney roots and signs of infiltration

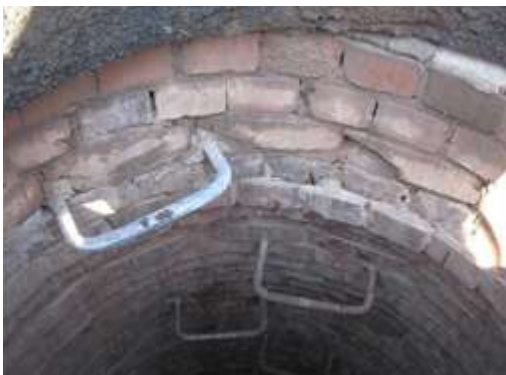
Defect 1

chimney loose bricks and mortar

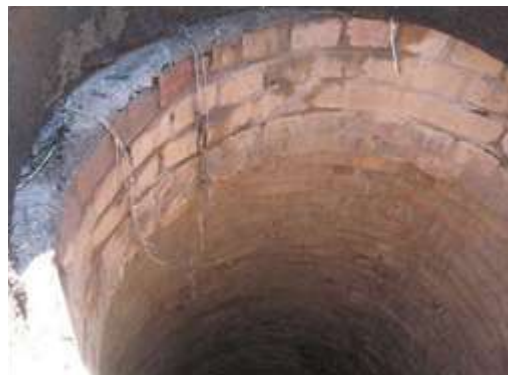
Defect 5

Frame Offset: **2.5** (in.) Condition: ☒ Sound ☐ Cracked ☐ Leaks

frame offset 2.5"

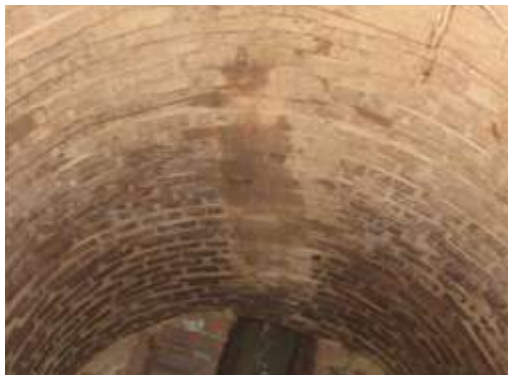
Defect 4

Infiltration: ☐ None ☐ Joint ☐ Cracks ☐ Mortar ☐ Roots ☒ Wall

infiltration in cobel wall

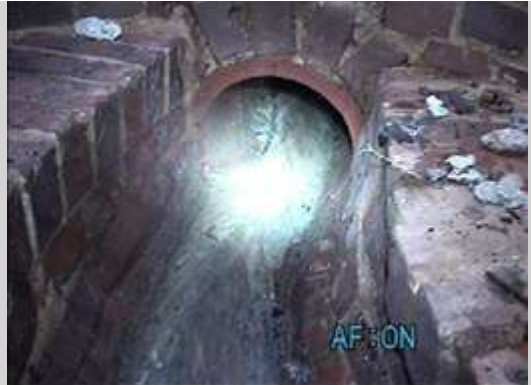
12 O'Clock Outflow

10 in. Circular Gravity Sewer
Pipe Out @ 12 O'Clock

Pipe Height: **9.6** (in.) Rod and Bar (Angled)
Pipe Material: **Clay** ☐ Pipe Lined
Invert Depth: **11.62** (ft.) Flow Characteristics: **Fast**
Deposits: ☒ None ☐ Mud ☐ Sludge ☐ Debris ☐ Grease
Silt Depth: **0** (in.) Deposits Extent:
Infiltration: **None** Pipe Seal Cond: **Sound**

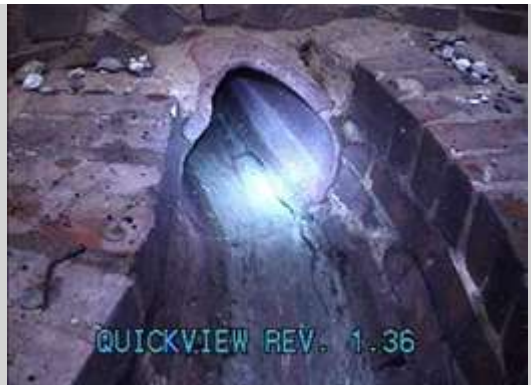
4 O'Clock Inflow

10 in. Circular Gravity Sewer
Pipe In @ 4 O'Clock

Pipe Height: **9.6** (in.) Rod and Bar (Angled)
Pipe Material: **Clay** ☐ Pipe Lined
Invert Depth: **11.45** (ft.) Flow Characteristics: **Fast**
Deposits: ☒ None ☐ Mud ☐ Sludge ☐ Debris ☐ Grease
Silt Depth: **0** (in.) Deposits Extent:
Infiltration: **None** Pipe Seal Cond: **Sound**
